MACHINE SERVICE BULLETIN NO. 257

SUBJECT: Carriage Shift of LA-5 and
LA-6 Machines

DATE: July 31, 1939

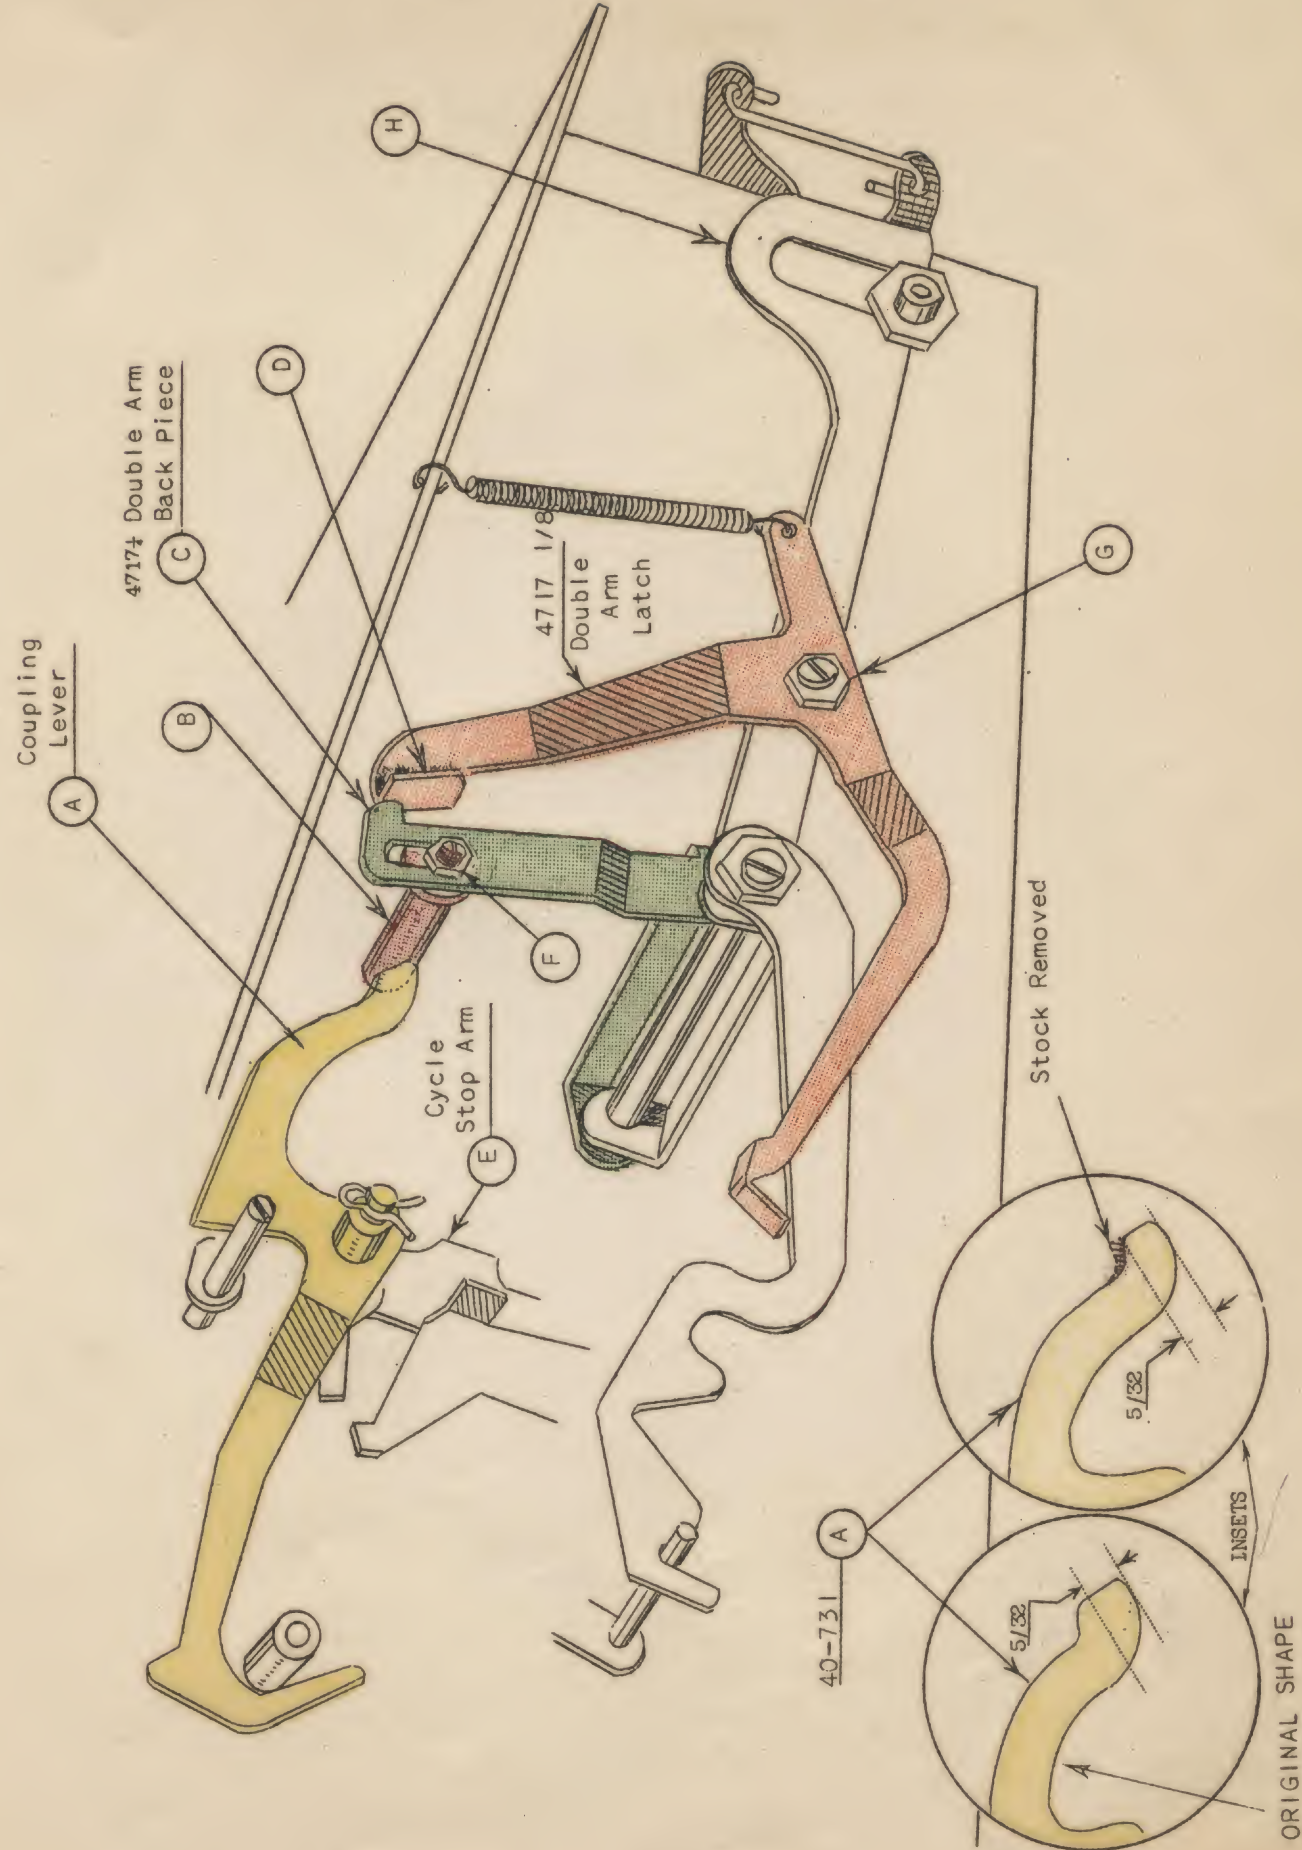
In order to obtain a satisfactory shift of the carriage on LA-5 and LA-6 model machines after all regular adjustments have been checked, servicemen have occasionally resorted to taking up on the clutch on the jack shaft until it failed to function as a slip clutch. To eliminate the need of such a practice, we suggest the removal of stock from the 40-731 coupling lever as illustrated on Plate 2 of this bulletin and the readjusting of the double arm latch 4717 1/8. Heretofore offset (D) was adjusted to (C) so that when the division lever was moved into operating position, (D) would latch under the step of (C) with as little excess clearance as possible and in order to insure the latching of (D) the 4717 1/8 was adjusted somewhat low. The natural result of this low adjustment was a loss of shift mechanism movement.

It will be interesting to note that after making this adjustment, (H) will be moved downward its entire distance before (A) starts to move under roller (B), thus proving that the grinding out of stock does not cause any loss of shift power.

Roller (B) can be adjusted lower by loosening nut (F). However, its downward adjustment is limited due to interference with a stud on the machine stopping lever.

The journey of the cycle stop arm (E) to the bumper pad following an overcarry trip in minus, causes an idle movement of (A) in relation to (B), but following an over-carry trip in plus, (A) contacts and pushes (B) forward, causing a carriage shift.

To provide an upward adjustment of the 4717 1/8 by means of eccentric (G) without the possibility of it failing to latch under the step of (C) during the minus bumper stroke following an over-carry trip, stock could be removed from (A) as shown in the insets on Plate 2. The absence of this stock permits (C) to pivot rearward slightly more during the minus bumper stroke, thereby, allowing offset (D) to latch with (C) although the 4717 1/8 was adjusted higher than previously. Also, it is no longer necessary for (D) to latch under the step of (C) when the division lever is moved toward the carriage.

After doing this it will be found that the slip clutch can be let out (friction reduced) considerably without retarding the carriage shift.
